Project: AGOR 28	Contract No.: N00014- 12-C-0305	Shipyard: Dakota Creek Industries	
Prepared by:	Date:	Program Officer:	
Paul D. Bueren	December 4, 2014	Robert (Tim) Schnoor	
Scripps Institution of		Office of Naval Research	
Oceanography (SIO)		875 Randolph St	
297 Rosecrans St.		ONR 321	
San Diego, CA 98106		Arlington, VA 22203-1995	
<b>Distribution Statement A</b> : Approved for public release;		Report No. A002.068

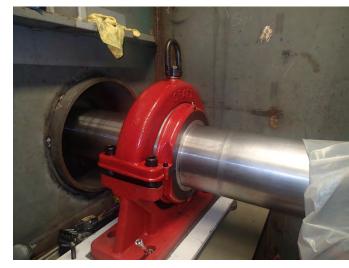
Intermediate Shaft Bearings Bearings have been installed on
Ride's modified foundations.
Alignment in progress on both
vessels.

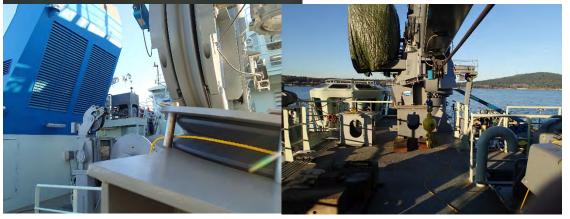
Side & CTD Handling Systems – Unresolved issues with fairlead

interferences from TK70-70 main crane remain. DCI is using Sally Ride's aft fairlead foundation to test various new locations on Armstrong. Ride's foundation was not permanently fixed so this is acceptable. The foundation was moved laterally to a position just inboard of the crane's boom and raised approximately 8-inches. This will allow the wire from the aft winch to pass aft of the cranes snout. It also appears that the forward winch will also be able to utilize this change in configuration. No permanent changes should be made until both winches and handling devices are operational. For the fwd winch and CTD handling device, issues still remain in regards to possible interference with the crane's winch and crutch. These can best be verified once the winches and handling systems are operational.

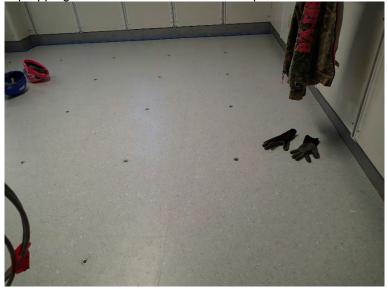
Deck Coverings – Tile has been installed over the Dexotex in Armstrongs ET Shop and the yard is prepping the Dexotex for tile in the Computer Lab. The look and fit appears to be excellent.
